Introduction for ACC FAC and Cycle Chemistry Session

Barry Dooley
Presented by Andy Howell
ACCUG 2019
Queretaro, Mexico
21st – 24th October 2019

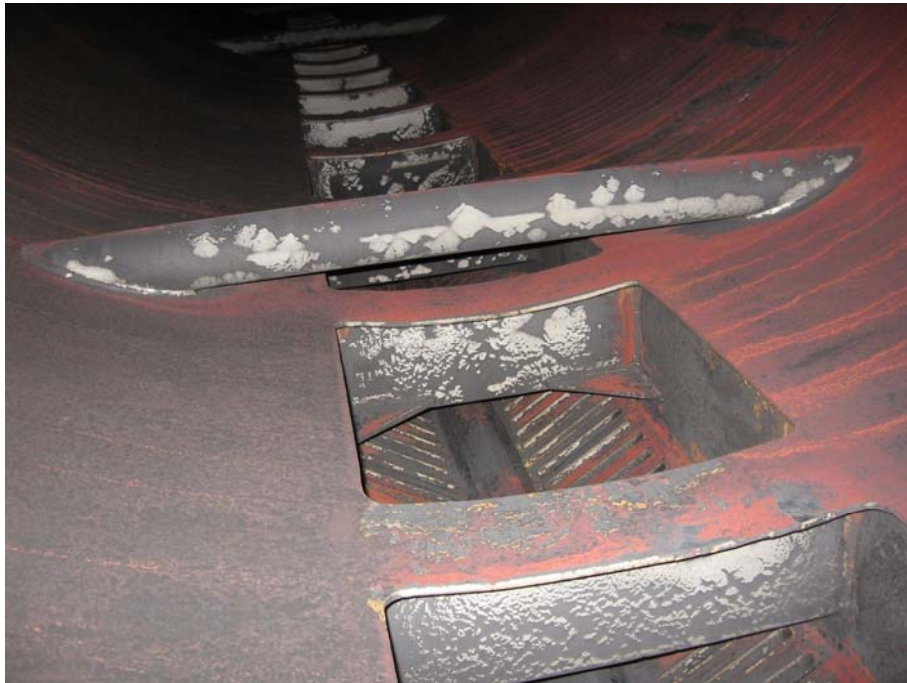
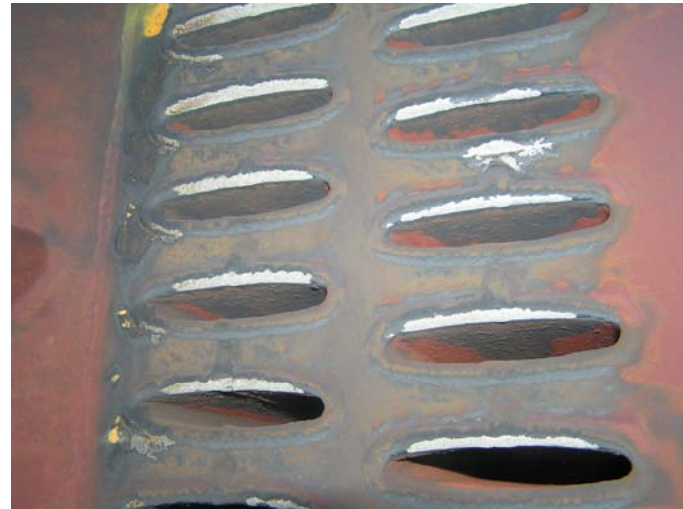
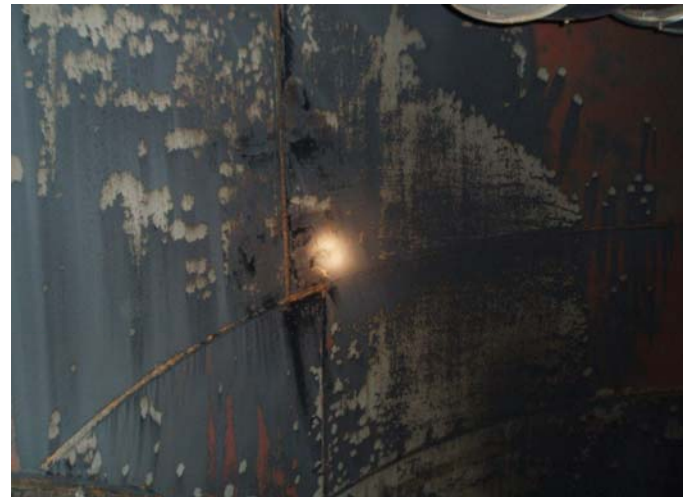
Typical ACC Damage

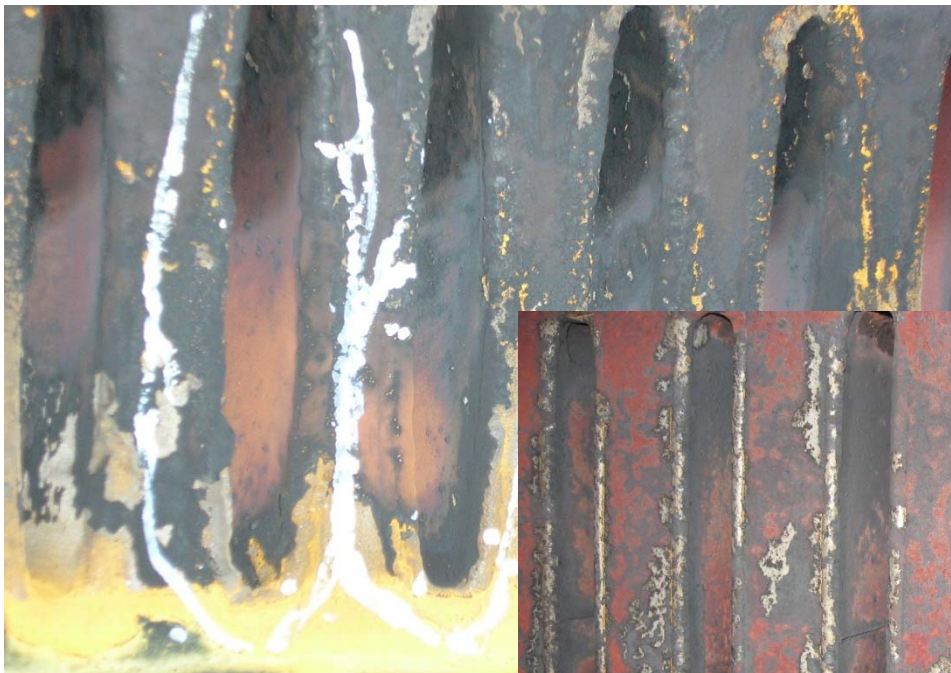
DHACI 3

We know what the Corrosion Looks Like

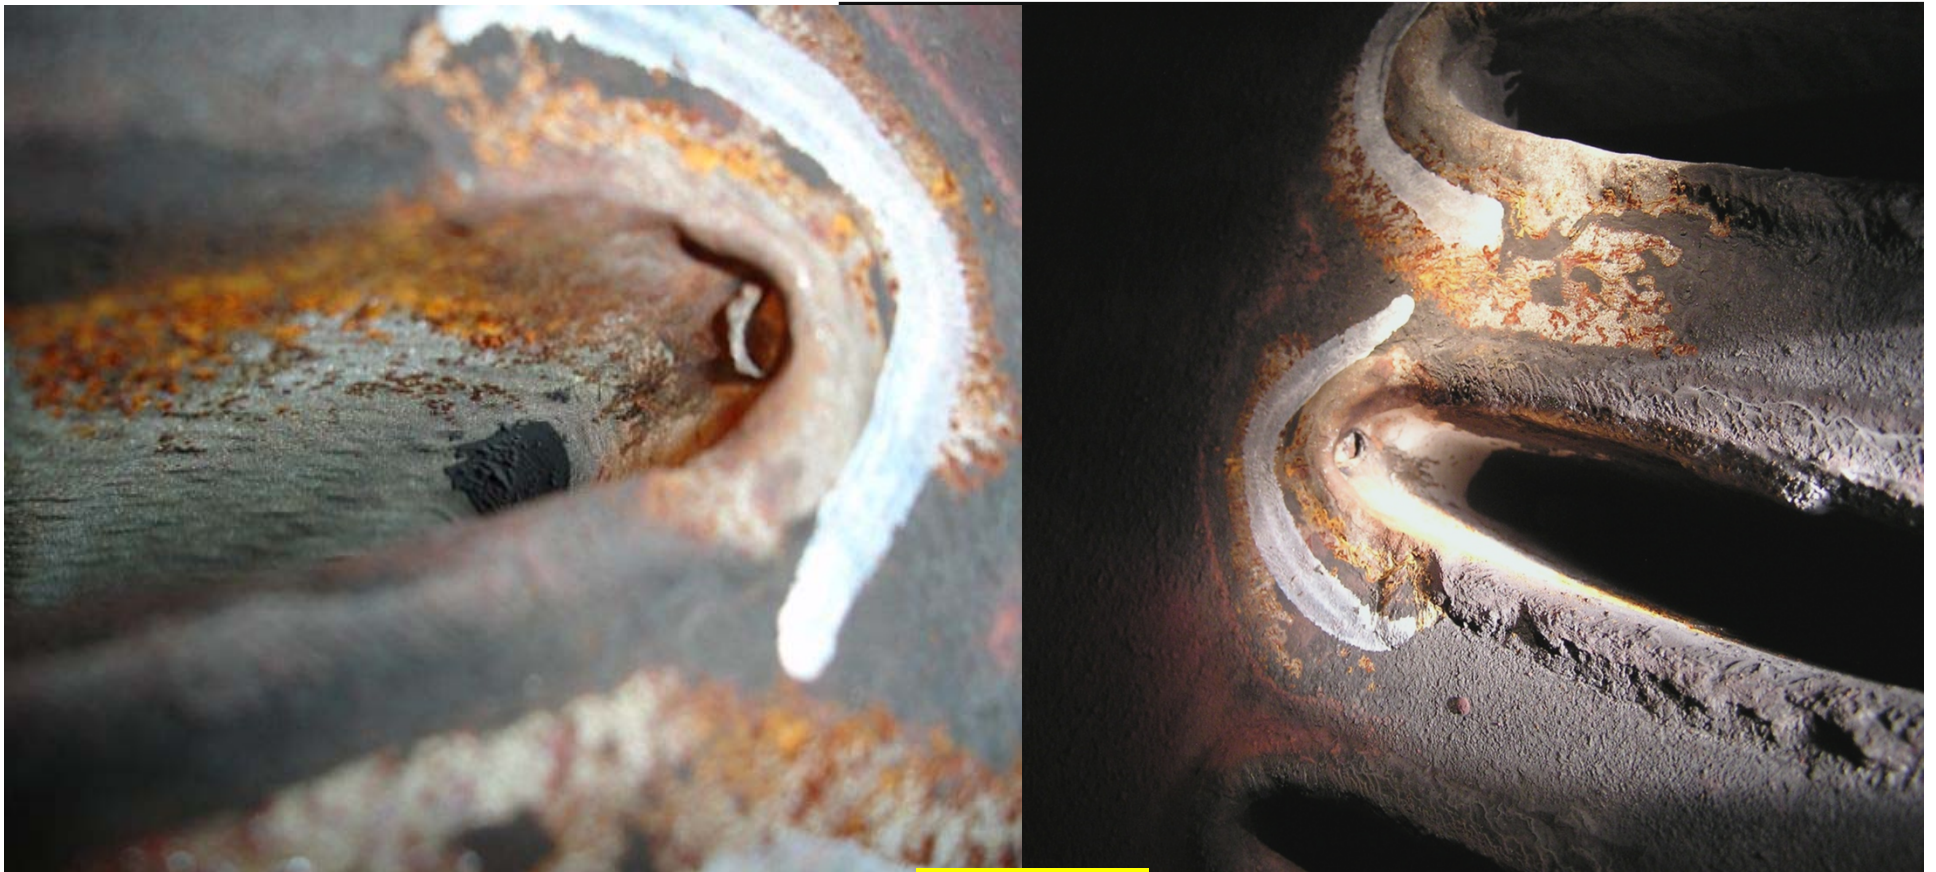
DHACI 5

and what Holes at Tube Entries Look Like

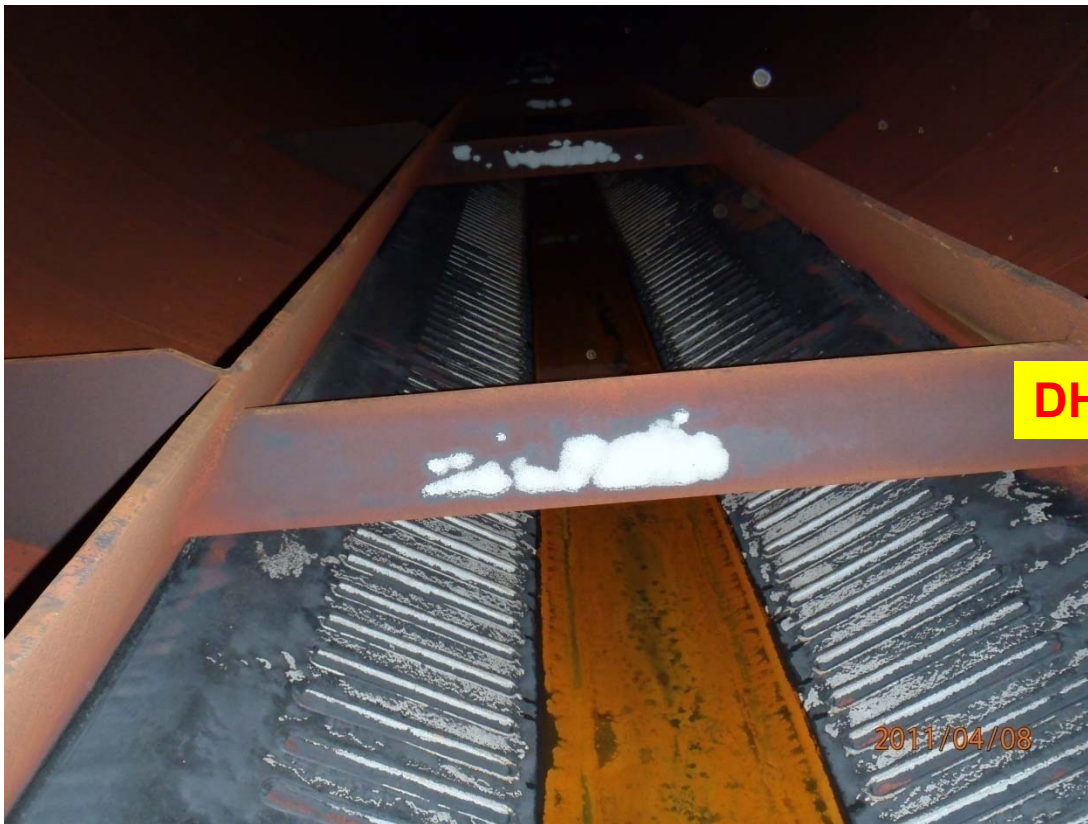
DHACI 4

Combined Cycle with ACC after ~ 15,000 hrs, pH 9.1.

Concentration of Two-phase
FAC beneath Supports

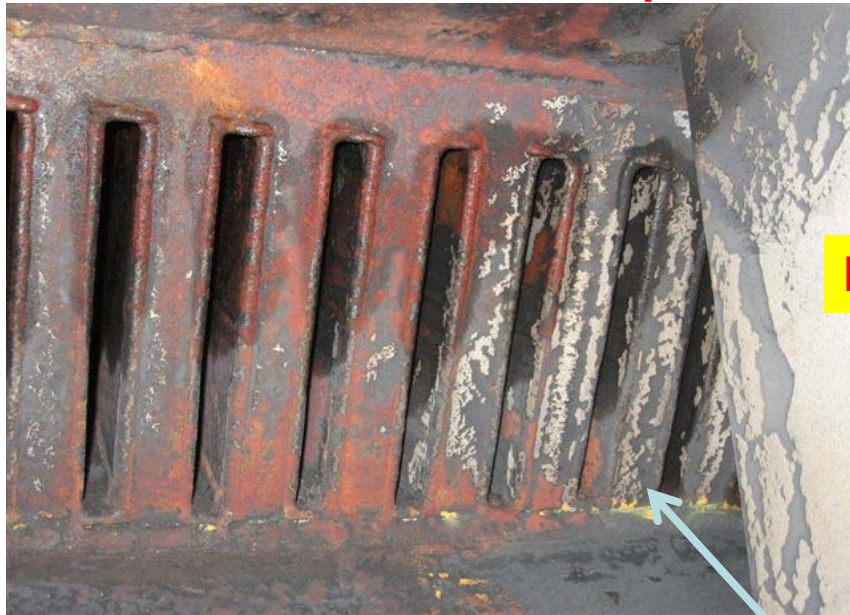
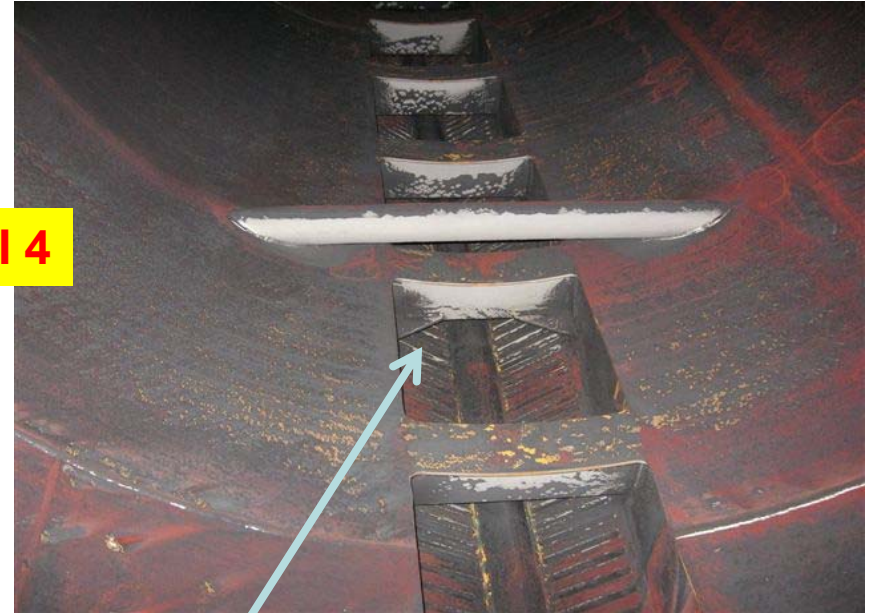
DHACI 4

750 MW Supercritical on OT at pH 9, ~4,000 hrs.

Concentration of Two-phase
FAC beneath Supports

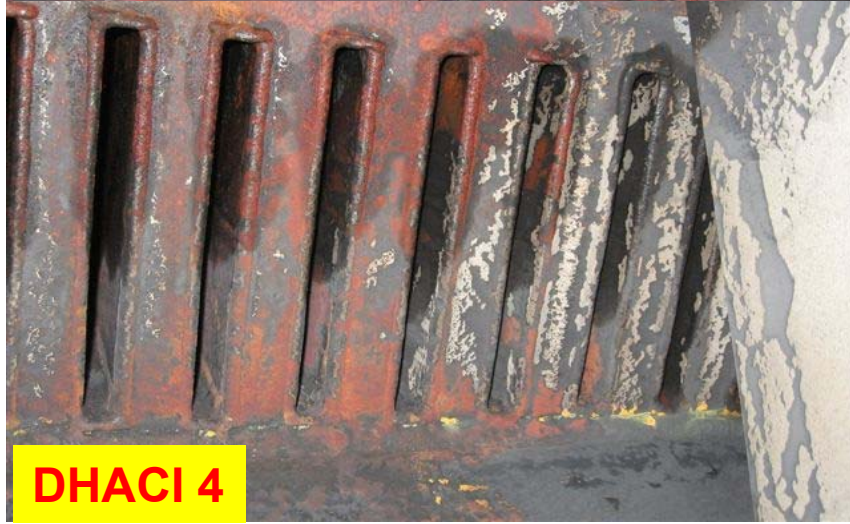
DHACI 4

Damage takes time to repair (ex. 2 Years with pH 9.8)

Cross member
LDI not quickly
“arrested” by pH

Damage on cross members is not “arrested” as quickly by increasing pH. Is this LDI caused by the larger droplets leaving the PTZ of the LP Steam Turbine?

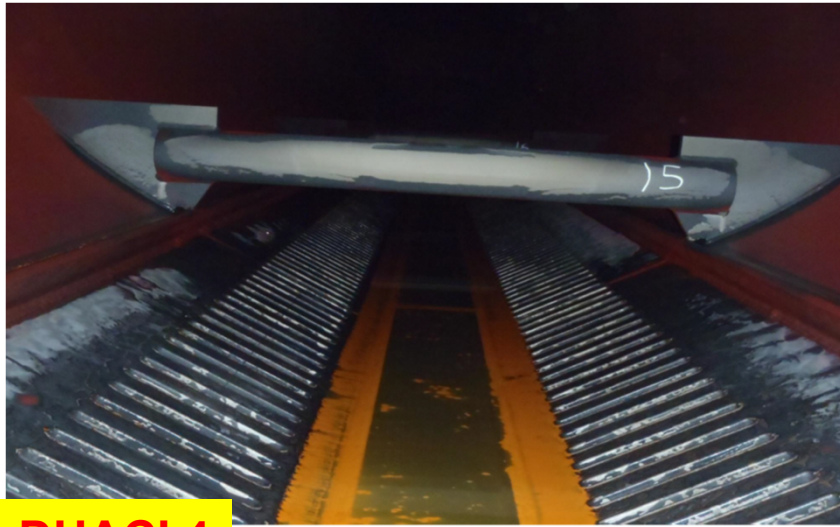
DHACI 4

Damage takes time to arrest (15 Months with pH 9.8)

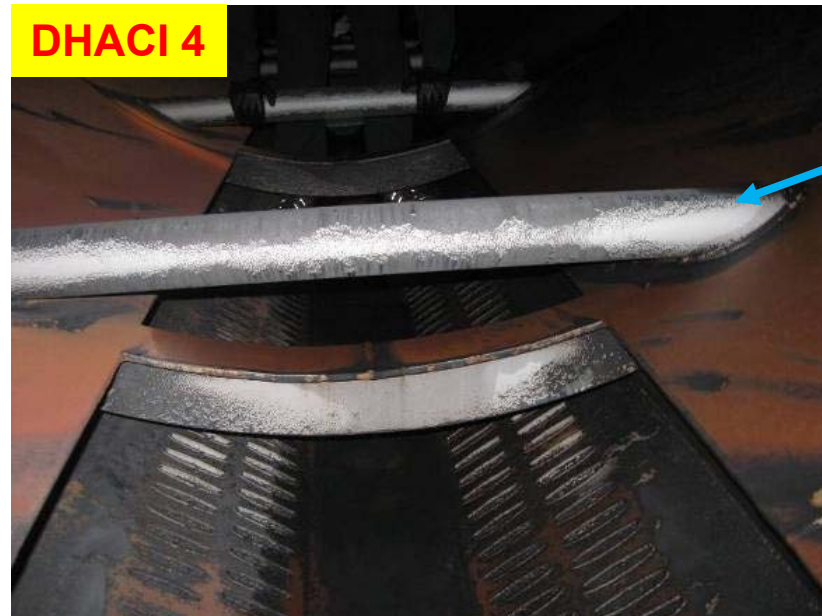
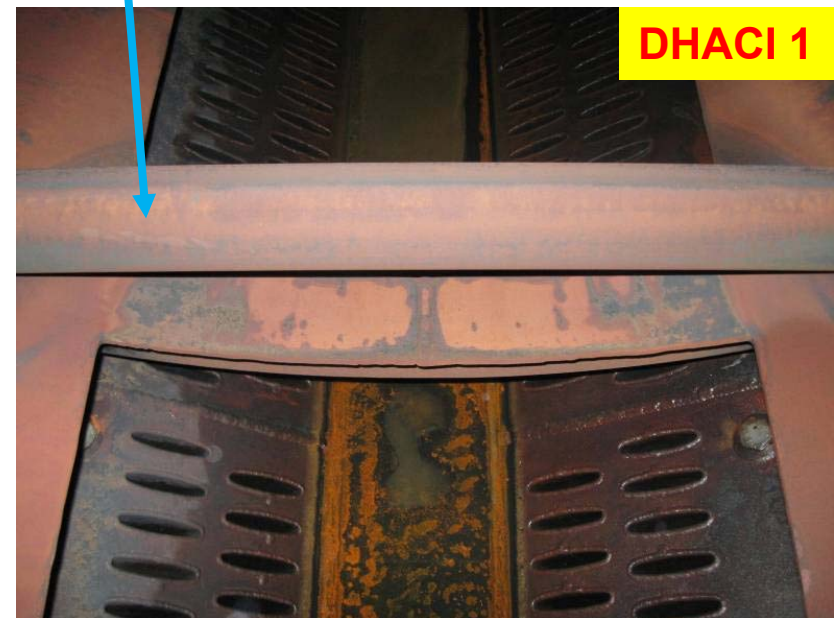
ACC “Arrests” with FFAP

**Cross member
appear to repair
using FFAP**

Courtesy Bill Stroman

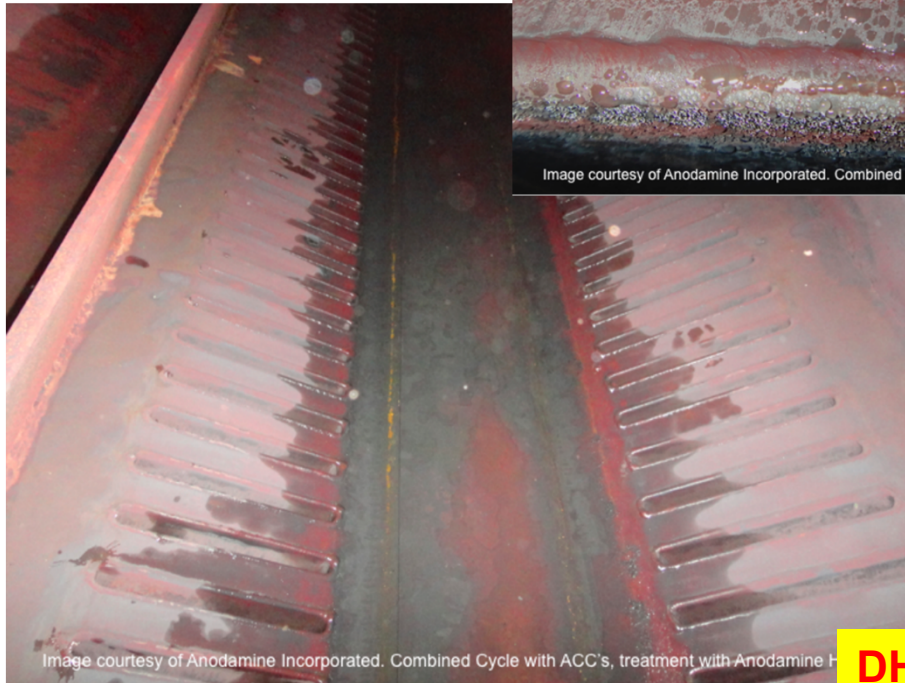
Image courtesy of Anodamine Incorporated. Combined Cycle with ACC's, treatment with Anodamine HPFG

DHACI 1
