ACC.02: Guidelines for Finned Tube Cleaning in Air-Cooled Condensers

Original Issue: November 16, 2018 Revision due: November 16, 2021

Guideline for Finned Tube Cleaning of Air-Cooled Condensers

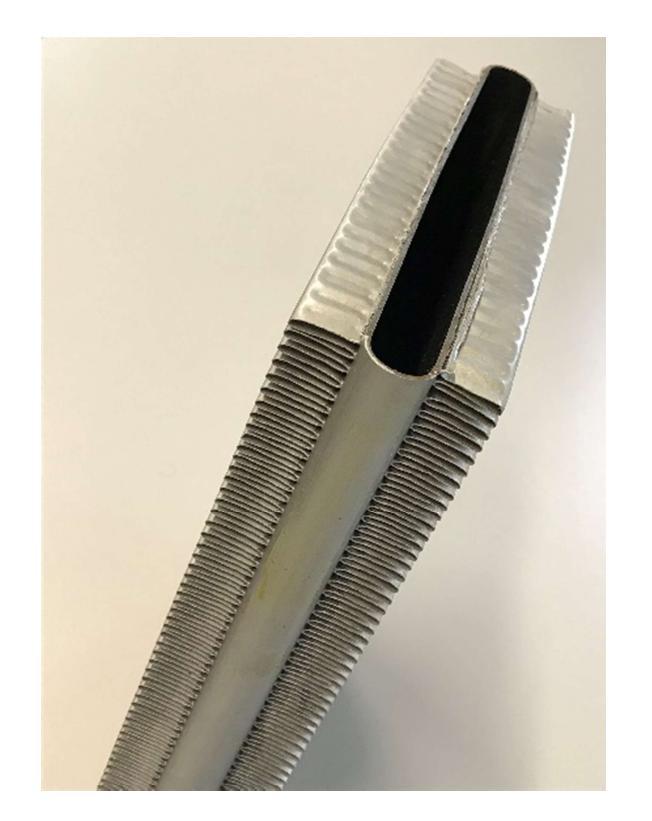
Figure 1: Typical heat exchange tubes in a singlerow design, carbon steel tube with aluminum fins and external coating.

Steam condensing in air-cooled condensers (ACCs) takes place in specialized heat exchanger tubes designed for optimal heat transfer. Typically, the tubes are composed of carbon steel with exterior (air-side) aluminum coating/cladding, along with external aluminum fins to increase the air-side surface area for heat rejection. Some ACCs, mostly earlier designs, included carbon steel fins on carbon steel heat exchange tubes, with the entire exterior coated with zinc. ACC tubes are normally oval or rectangular in shape and approximately 0.059" (1.50 mm) wall thickness, with closely-spaced fins to facilitate maximum surface area exposure to cooling air flow (Figures 1-3). Air flow is provided by large fans typically positioned below the array of finned tubes, directing air upward in a so-called "forced draft" situation (Figures 4, 5), although an induced-draft design with fans above the array has been introduced that has some potential advantages. High-purity steam exhausted from the low-pressure steam turbine with a few percent moisture (condensed water) travels through large ducts at relatively high velocity, generally at 120 - 360 fps (35 - 110 mps). Steam velocity is dependent on the vacuum; upon reaching the condenser tubes, flow is redirected and drawn into the tubes with a 90° turn. As the two-phase steam-water mixture moves down the 33 - 36 foot (10 - 11) meter tube length, the remaining steam is condensed to liquid water and releases the latent heat of vaporization.

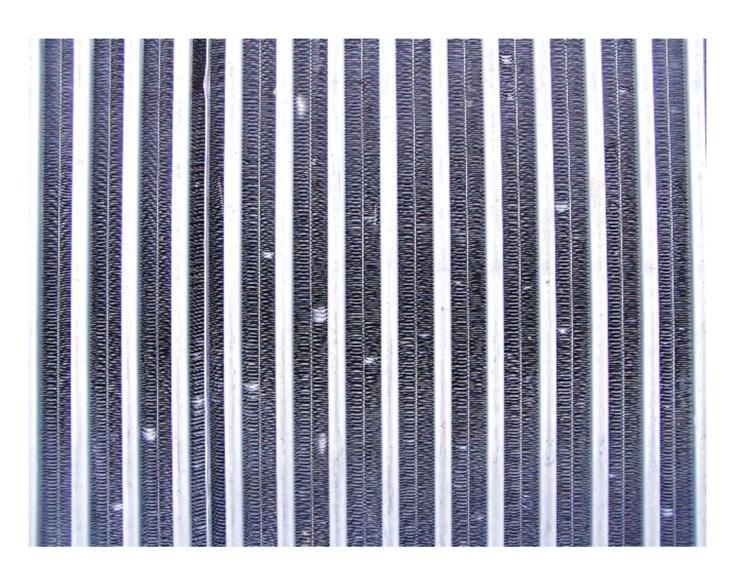
Figure 2: Tubes in an ACC viewed from the exterior (airside).

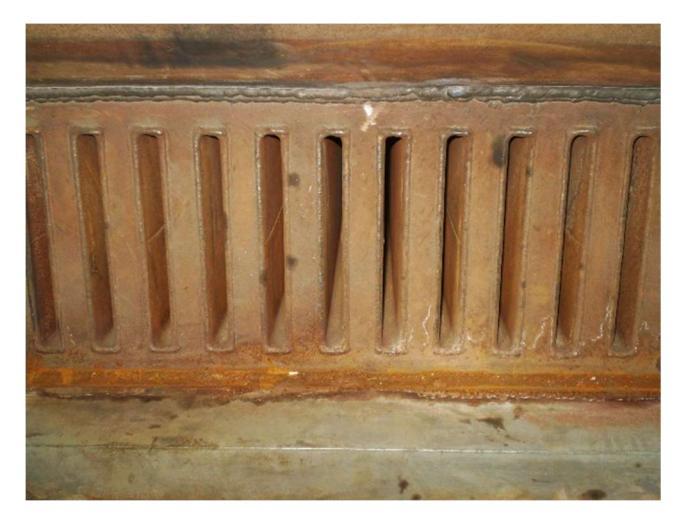
Figure 3: ACC heat exchange tubes viewed from inside the upper duct (steamside).

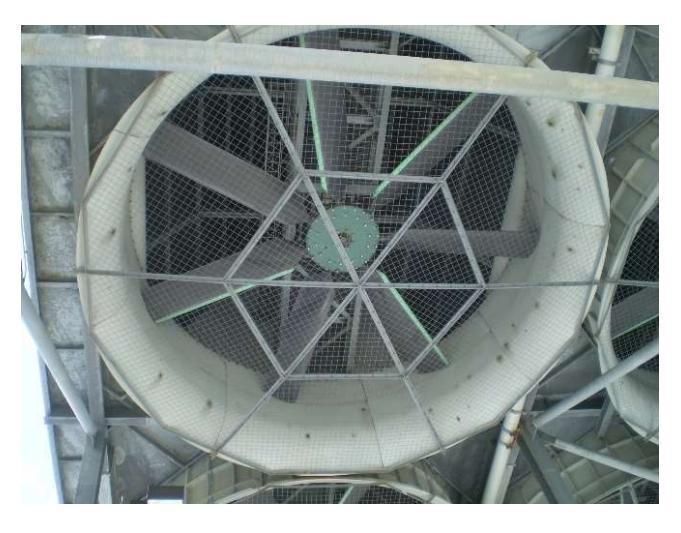
Figure 4: Large ACC fan viewed from beneath; air is typically forced upward through the finned heat exchange tubes.

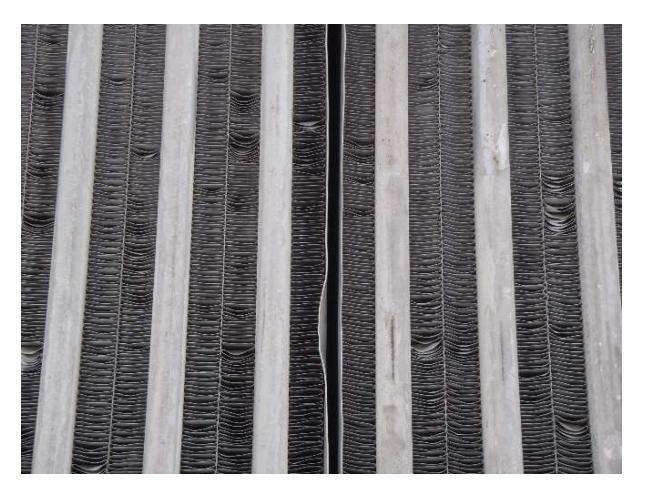
Figure 7: Gap between sets of tube bundles, allowing air to bypass cooling tubes.

While finned tube fouling is an inevitable source of performance deficiency, it should be considered as only one aspect of any program or effort to address performance limitations. For a cooling arrangement that invariably lacks efficiency under certain ambient conditions, any detail that improves heat transfer should be evaluated for costeffective optimization. In addition to removing foulants from finned tubes (discussed in the subsequent sections of this document), other examples of these types of issues include bent aluminum fins (e.g. damaged by hail or other objects), pathways for air to bypass the cooling tubes (typically at tube-to-header regions and poor fit between prefabricated tube sections), and open doors in between fan bays, as well as the exterior doors at either end of the street (Figures 6 - 7). Fan pitch must be optimized if airflow is to be maximized, and increasing fan speed with new re-sized motors may result in costeffective improvements. Airflow modifications such as windscreens, including automated movable screens, can be very beneficial as well, with maintaining windscreen cleanliness an important consideration. These and other similar sources of incremental loss of heat transfer efficiency can add up to a significant overall performance loss, with fuel and financial penalties incurred. Corrective actions are often possible, such as a "combing" tool that could restore a flow path through bent fins, and insertion of suitable material to block gaps between tubes or tube sections (Figure 8).

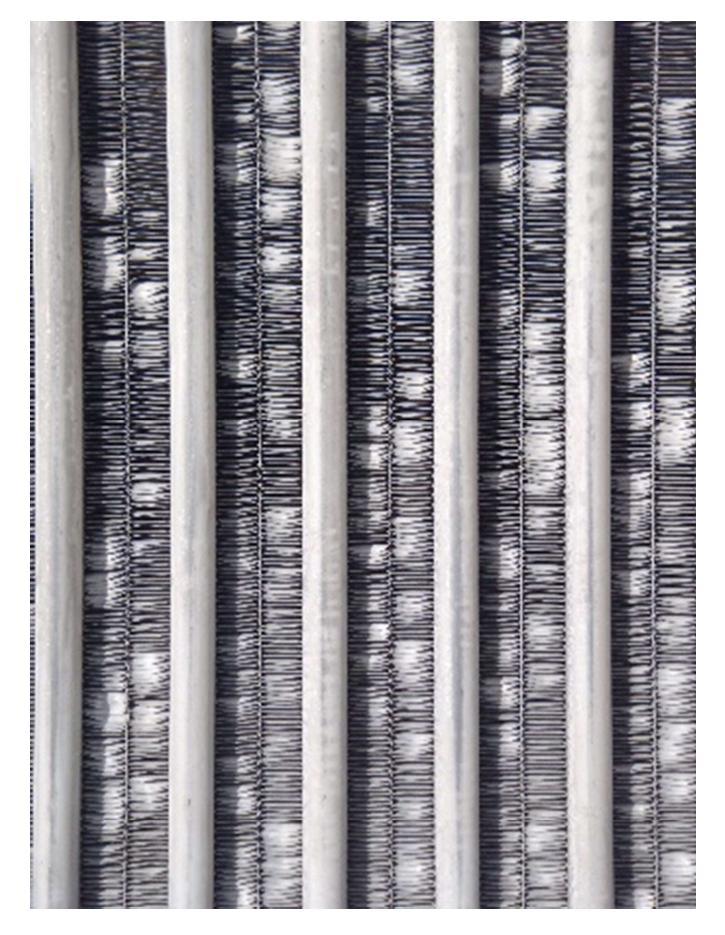
Figure 6: Aluminum fins on exterior of A-frame, damaged by hail.

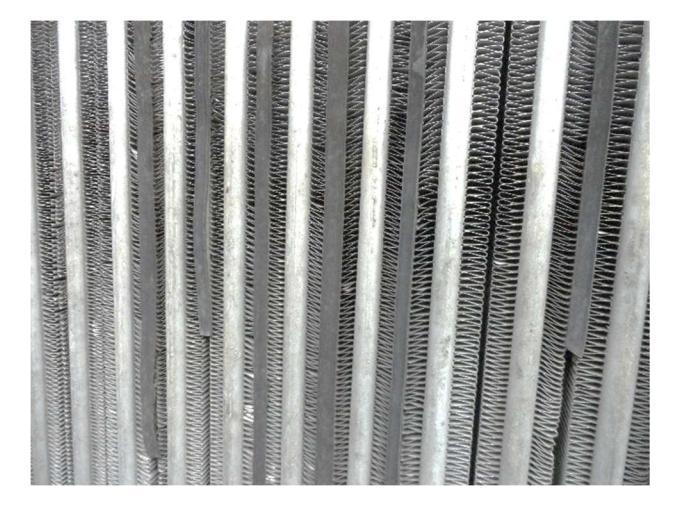
Figure 8: Gaps between individual ACC tubes blocked with rubber strips to minimize air bypass.

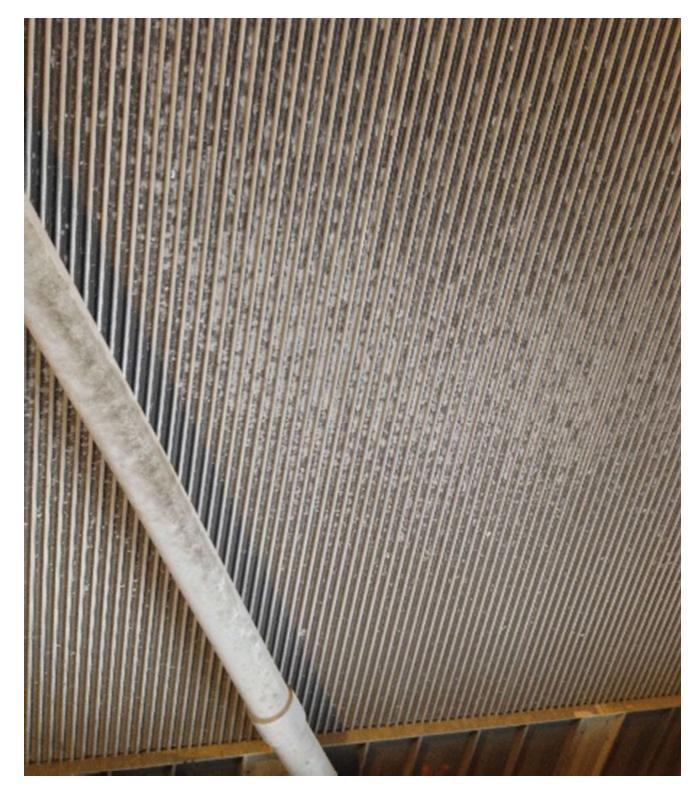
Figure 9: Underside (fan-side) of A-frame with significant debris blocking airflow through fins.

Cooling fans moving high volumes of air through narrowly-spaced fins will inevitably result in the accumulation of airborne debris on the fan-side of the finned tube A-frame, with the closely-spaced fins acting somewhat as an air filter. Blockage in air passageways prevents optimal heat transfer, reducing steam condensing efficiency and degrading condenser vacuum. There is a wide variety of types of debris, which is location-specific. Typical blocking materials include those from animal sources (birds or bats, feathers, flying insects such as moths), vegetation (cottonwood seeds, leaves), and trash (plastic bags, paper) (Figures 9 - 10).

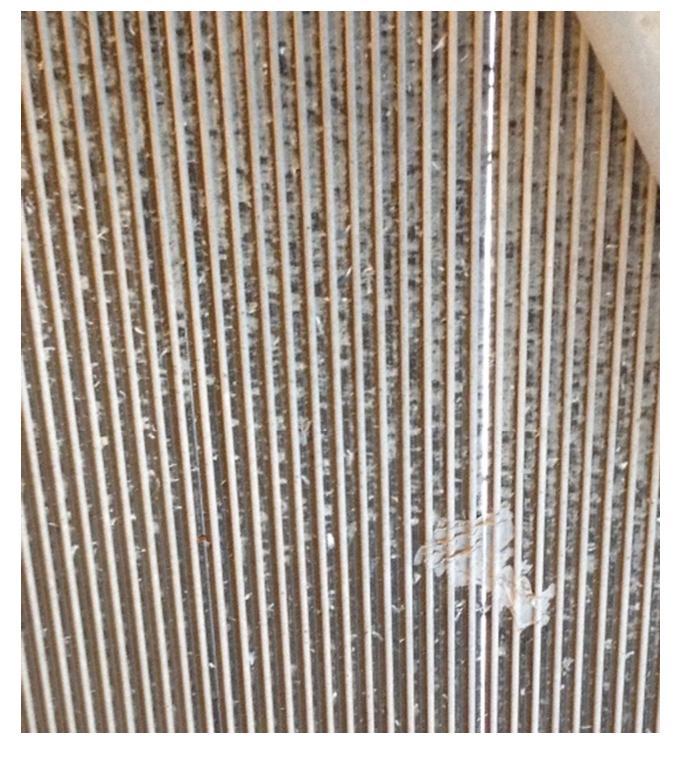
Figure 10: Debris on fins; note plastic bag.

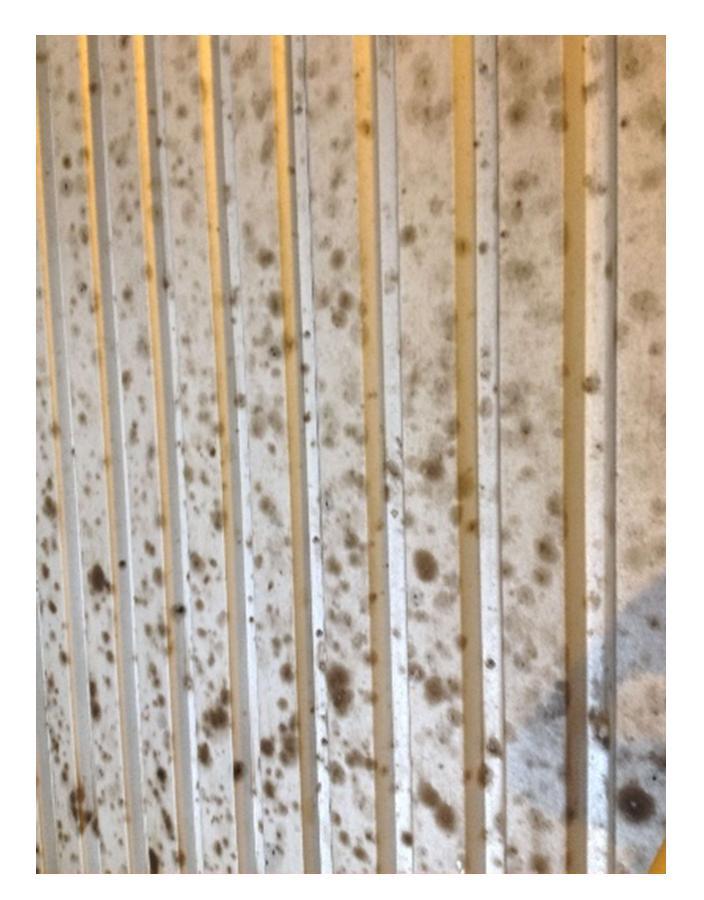
Figure 11: Gearbox oil splatter in fan bay.

One particularly troublesome foulant is oil from fan gearboxes (Figure 11). Gearbox oil can leak and travel down fan blades, ultimately being discharged from the end of the blade and carried with airflow to the finned tubes. This oil is both heat-insulating and can serve as a 'glue' to which airborne sediment and other debris can adhere. As

gearbox oil is very insoluble in water, its removal can be challenging. Appropriate gearbox monitoring and maintenance will reduce the extent of oil leakage and fouling.¹ It has also been recommended that the lower fan thrust bearing be lubricated with grease, which will keep gearbox oil from the bearing and help prevent its dispersion.

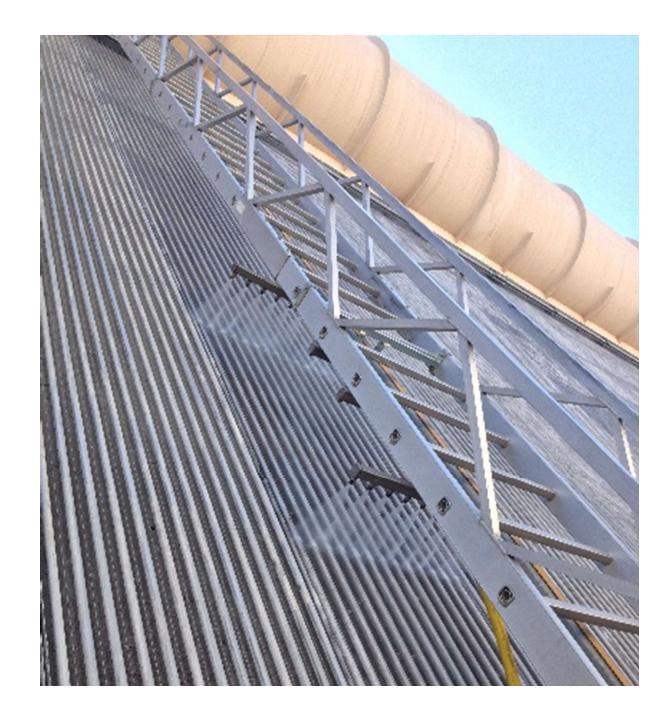
Figure 12: Water-spray washing with a permanently-mounted system.

In practice, pressurized water washing of finned tubes is usually done with a commercially-available semi-automatic system that moves multiple spray nozzles automatically in the vertical direction on a track that can be manually moved in the horizontal direction along a tube street (Figure 12). A cleaning system with full automation may be considered if temperatures on the ACC deck are too high for personnel safety, or if labor costs are high.

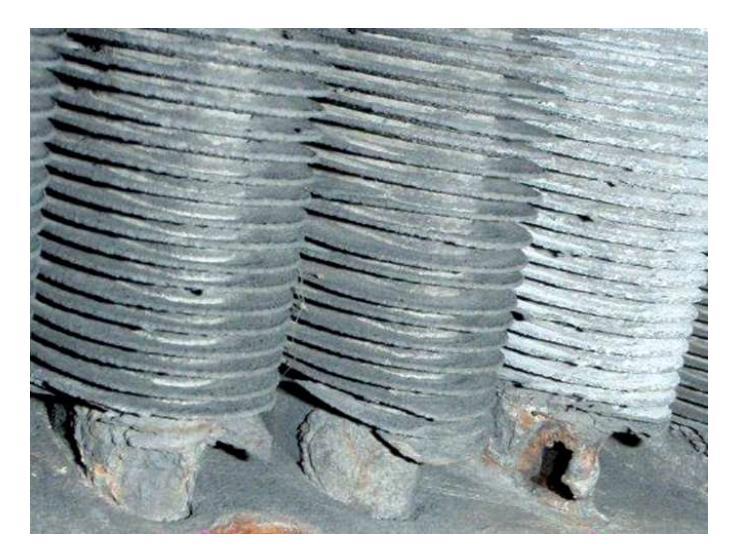
Figure 13: External corrosion of finned tubes due to poor quality water supply.

- water quality is specified to avoid corrosion or scaling / deposition of mineral deposits on tube surfaces (Figures 13, 14); dissolved mineral content of potable quality or better is needed

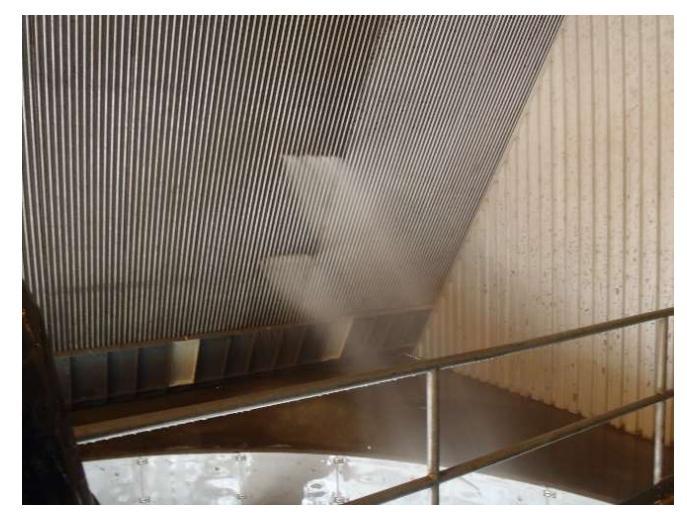
Figure 15: Finned tube water-washing, fan bay interior.

The fan in the cell being cleaned should be turned off to allow cleaning water containing fouling debris to drop to fan deck or ground level with gravity and avoid re-entrainment in the air flow (Figures 15, 16). Cleaning with the fan on may cause tubes to distort due to quenching and could also result in disbonding of external surface coatings. Some operators prefer to turn off all fans in the vicinity, to avoid debris being picked up with air flow and re-deposited in adjacent cells. Some of the removed material may end up on the fan deck, and other may be rinsed to the ground below the ACC. Material on the fan deck, as well as that rinsed to the ground, should be manually collected for disposal if possible, or else it may be swept up and foul tubes again after cell operation recommences.

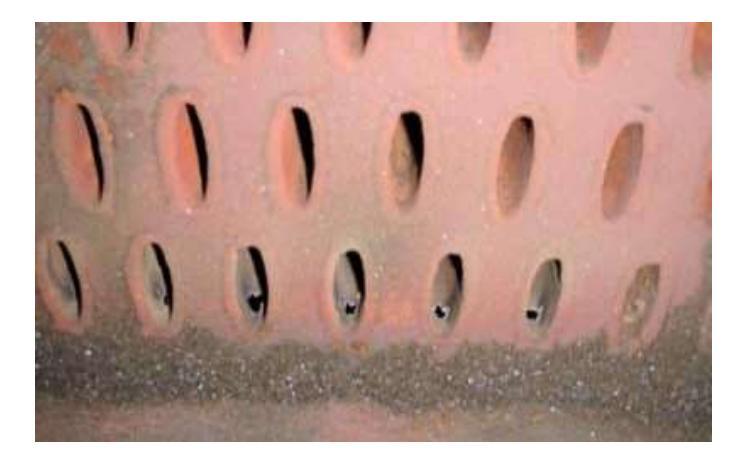
Figure 14: Steamside tube entries with throughwall corrosion from exterior.

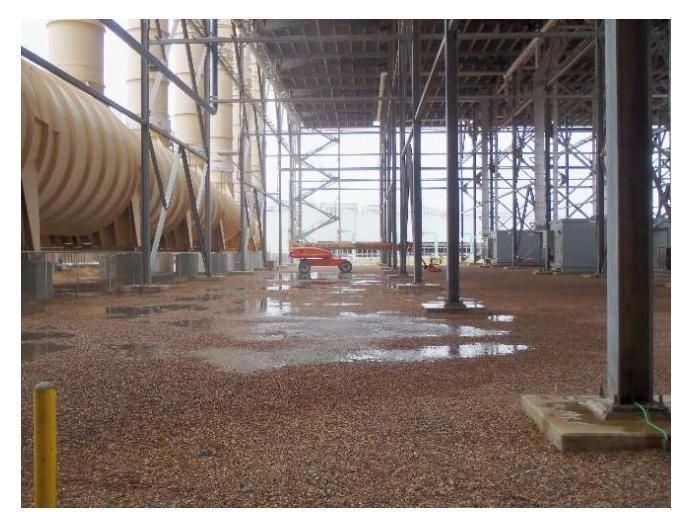
Figure 16: Water under ACC after finned tube cleaning.

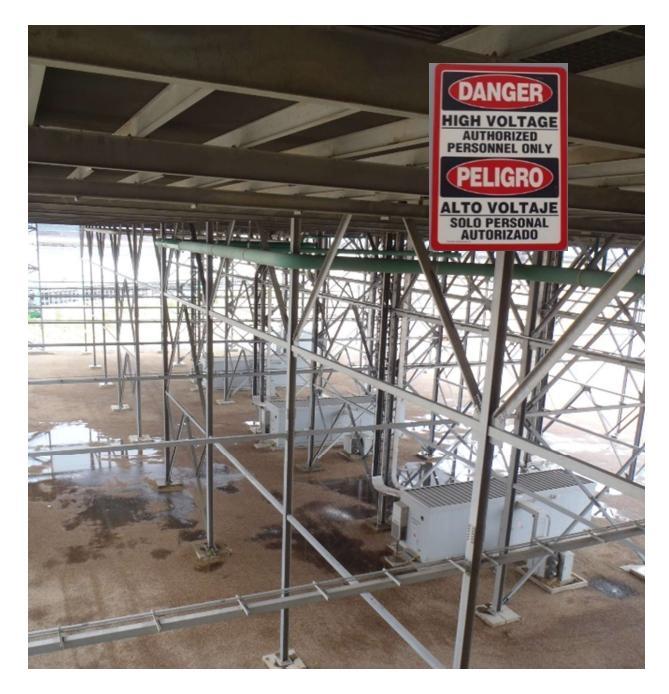
Figure 17: Electrical equipment under ACC.

It is common to site electronic controls at ground level beneath an ACC (Figure 17). While these are designed for protection from weather, deluge water such as may be encountered in finned tube washing poses a potential risk of an electrical short and damage to this equipment. In addition, it is important to protect the gearbox and motor from water exposure in a cell where cleaning is taking place by thoroughly protecting it with a waterproof barrier such as heavy plastic or by some similar means; this barrier

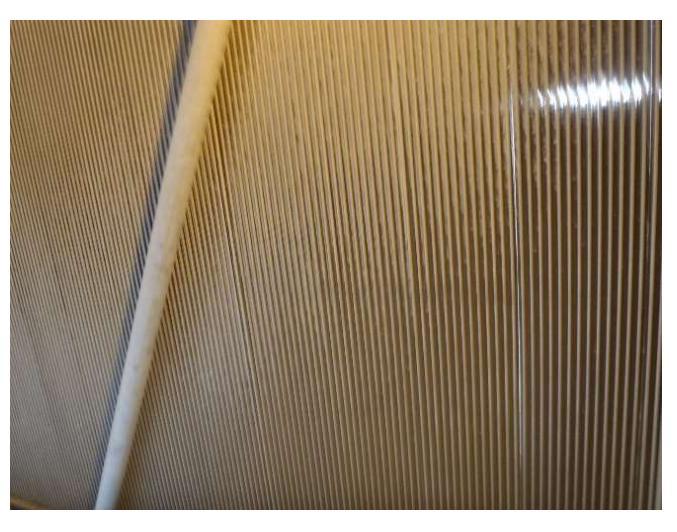
Figure 19: Finned tubes after cleaning; sunlight showing clear path through fins where blockage is minimal.

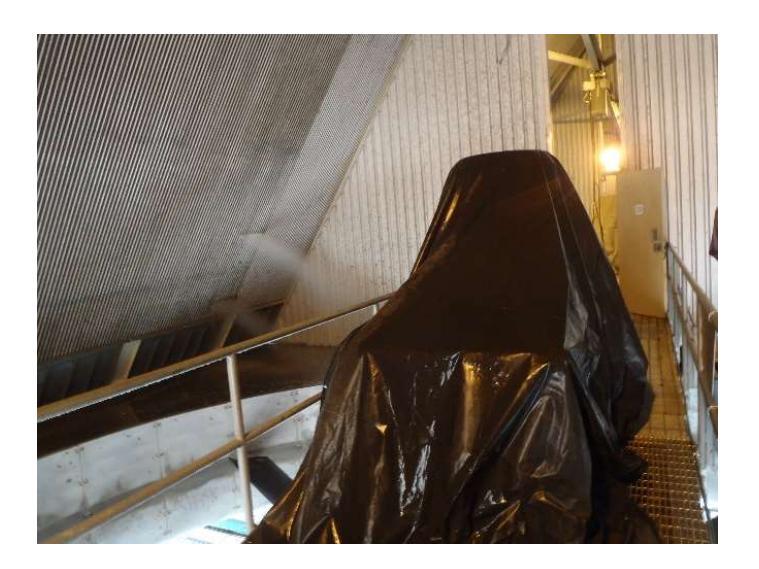
Figure 18: Fan motor/gearbox covered during water spray cleaning to protect from water.

must be tied down / attached firmly in place (Figure 18). In spite of these precautions, gearbox breathers should be checked after the cleaning to ensure that they have not become wet. The fan hoist and pendant must also be moved away from the cell being cleaned, or it may collect water and require replacement.

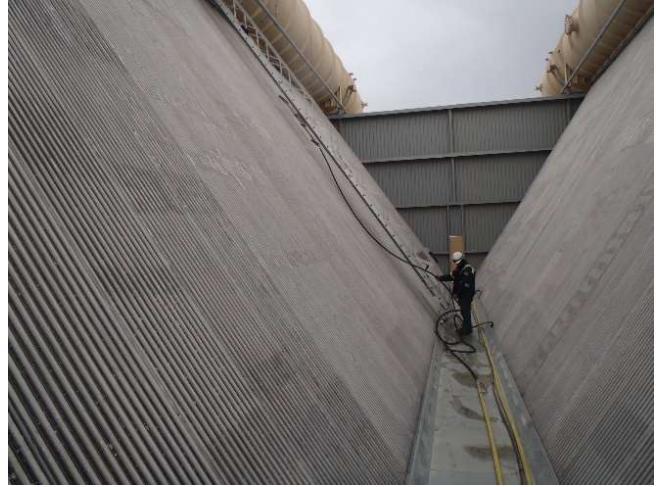
Figure 20: Semi-automated finned tube wash system operated by one person.

There are two basic approaches to carrying out water-washing of finned ACC tubes. The preferred option is to have a permanently-installed pressurized spray system on each street, with a single accompanying pump and water supply system. Having this arrangement in place increases the likelihood that cleaning will take place, since the only significant requirement for carrying out the cleaning is to provide personnel to accomplish the task. The work can be accomplished by a single person if convenient (employee or contractor), albeit at a relatively slow pace (Figure 20).
