## ACCUG: Corrosion and Cycle Chemistry

Fossil, Combined Cycle/HRSG and Industrial Plants  
Review of History over Last 20 Years

ACCUG 2026  
14<sup>th</sup> & 15<sup>th</sup> July 2026  
Clarksville, Tennessee

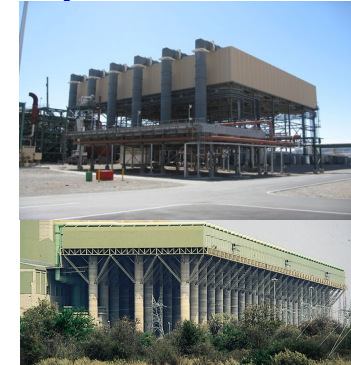
## ACC Come in Many Sizes

But the two-phase FAC at the tube entries is the same worldwide with all chemistries and plant types (Based on assessment/inspection work conducted in Australia, Canada, Chile, China, Cote d'Ivoire, Dubai, India, Ireland, Mexico, Qatar, Abu Dhabi, South Africa, Trinidad, UK and US)

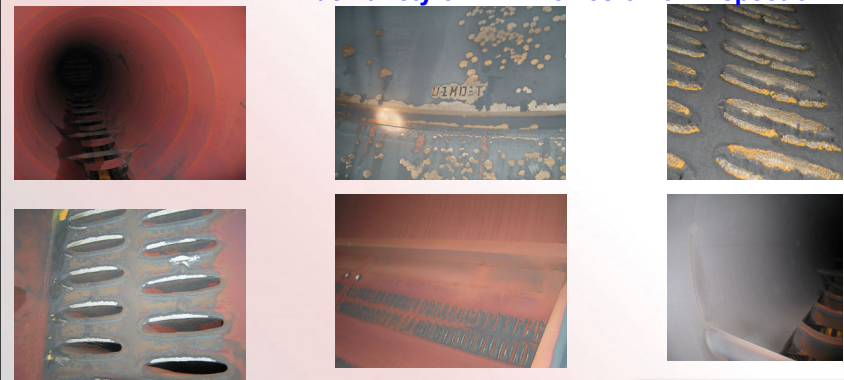
## A Wide Variety of ACC Corrosion on Inspection

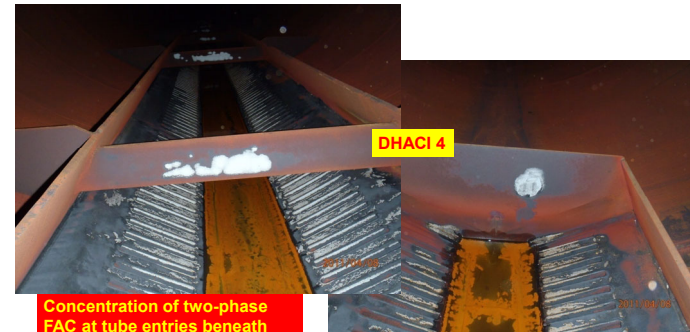
### Inspections Worldwide show the same Features

Combined Cycle with ACC after ~ 15,000 hrs, pH 9.1.

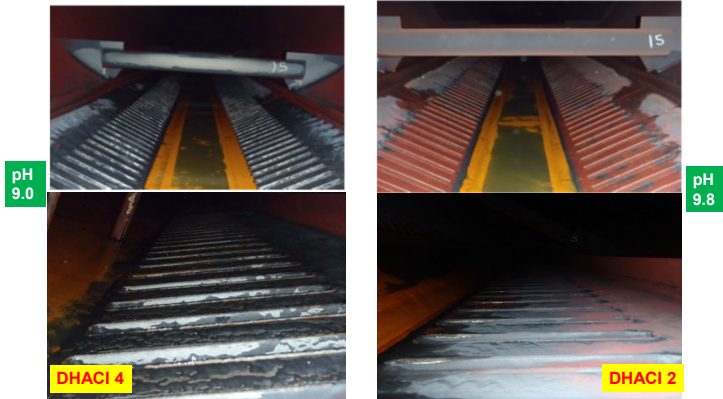
### Damage takes time to arrest (15 Months with pH 9.8)

Increasing condensate pH to 9.8 will gradually eliminate the FAC damage at the tube entries and iron levels will reduce to international (IAPWS) suggested levels (5 - 10 ppb) at CPD. Documented by a decreasing DHACI. FFS sometimes will work but not sufficient detailed documentation of ACC before and after application and currently no understanding of/for improvement using the wide range of FFS.

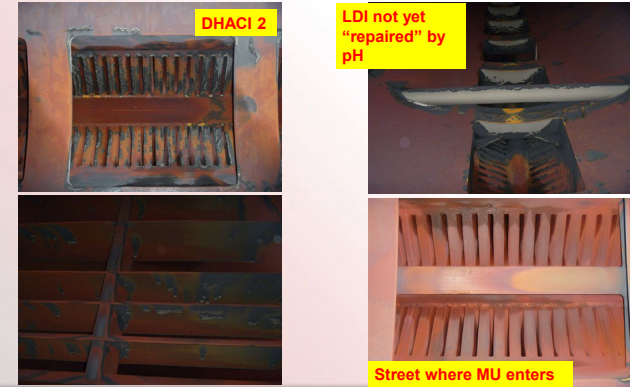
### Damage takes time to arrest (2 Years with pH 9.8)
